TRACY MEMORIAL VILLAGE HALL

CHATHAM, NEW YORK

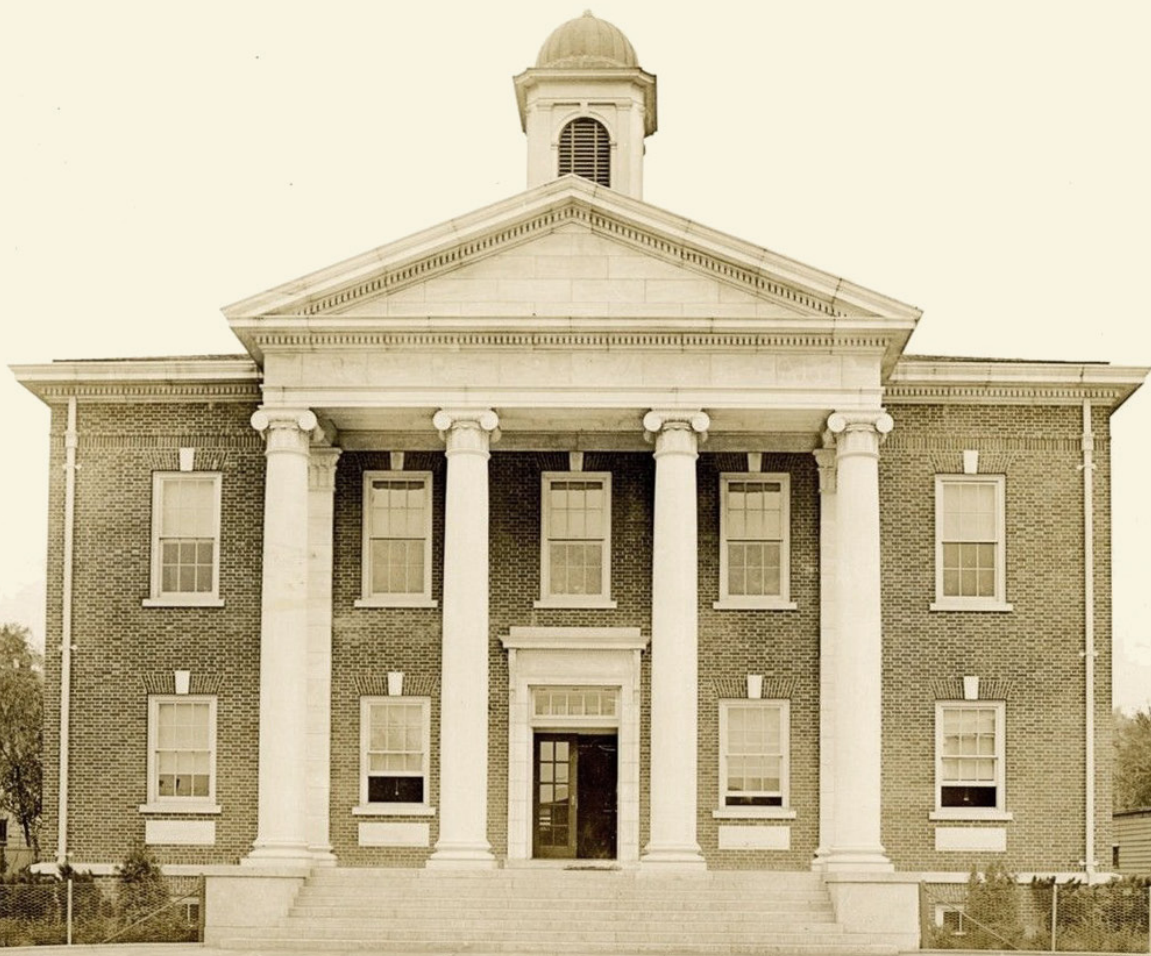
TRACY MEMORIAL VILLAGE HALL, CHATHAM, N. Y.

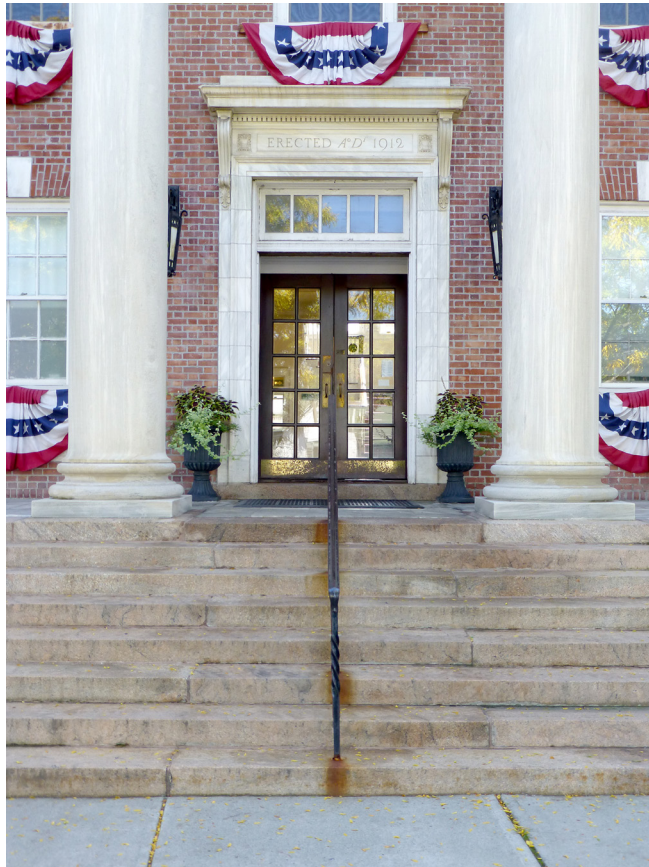
(Left) West Entrance Steps. Historic sliding doors have been removed from the main entrance. The contemporary handrail is rusting, and staining the granite steps. [JGWA 2014]

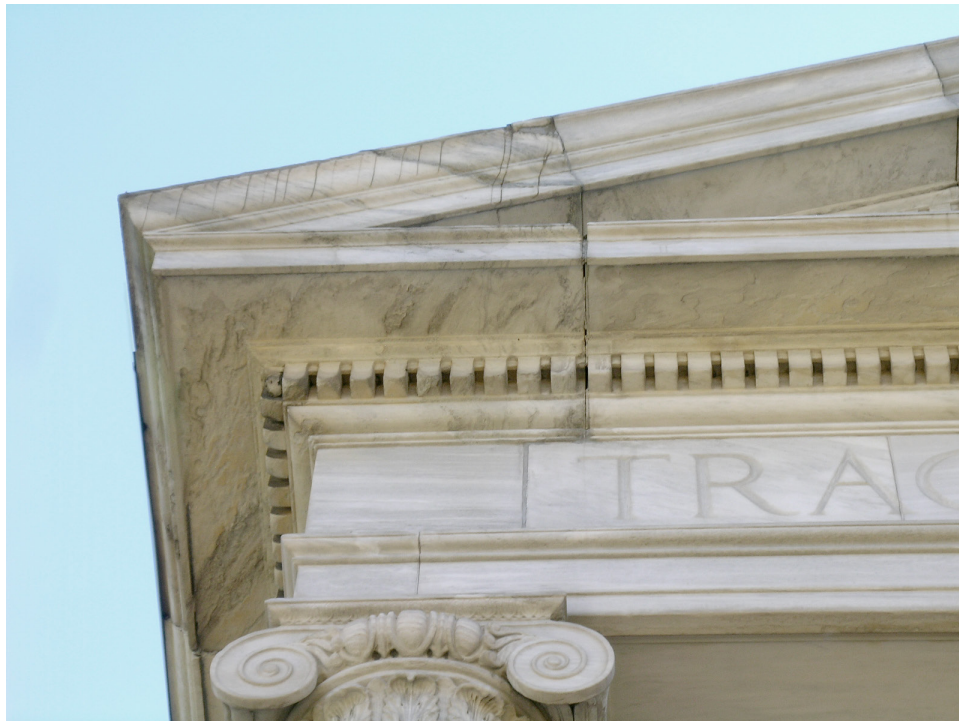
(Below) Black drips and yellow discoloration are visible on the west pediment. [JGWA 2014]

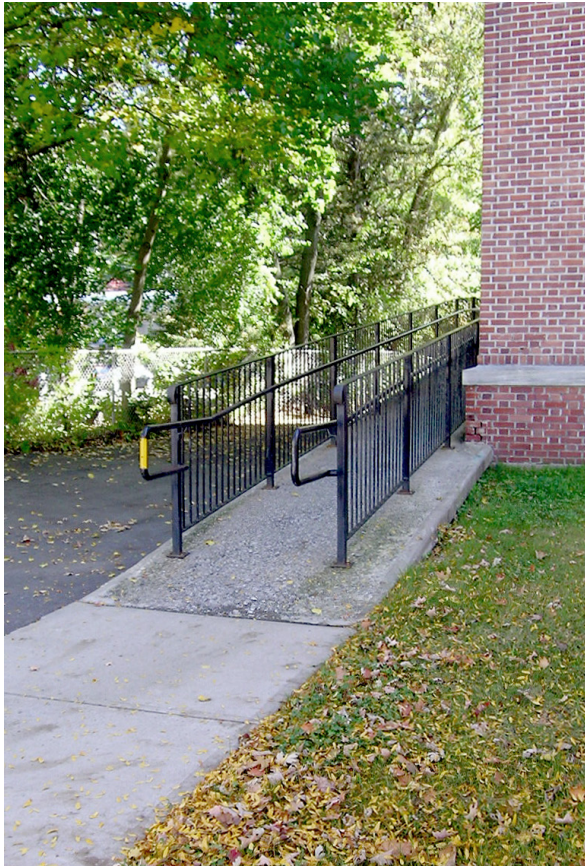
(Left) The surface of the handicap accessible ramp is badly worn from roof run off, and mortar has washed out from the mortar joints above the area where the ramp intersects the west wall. [JGWA 2014]

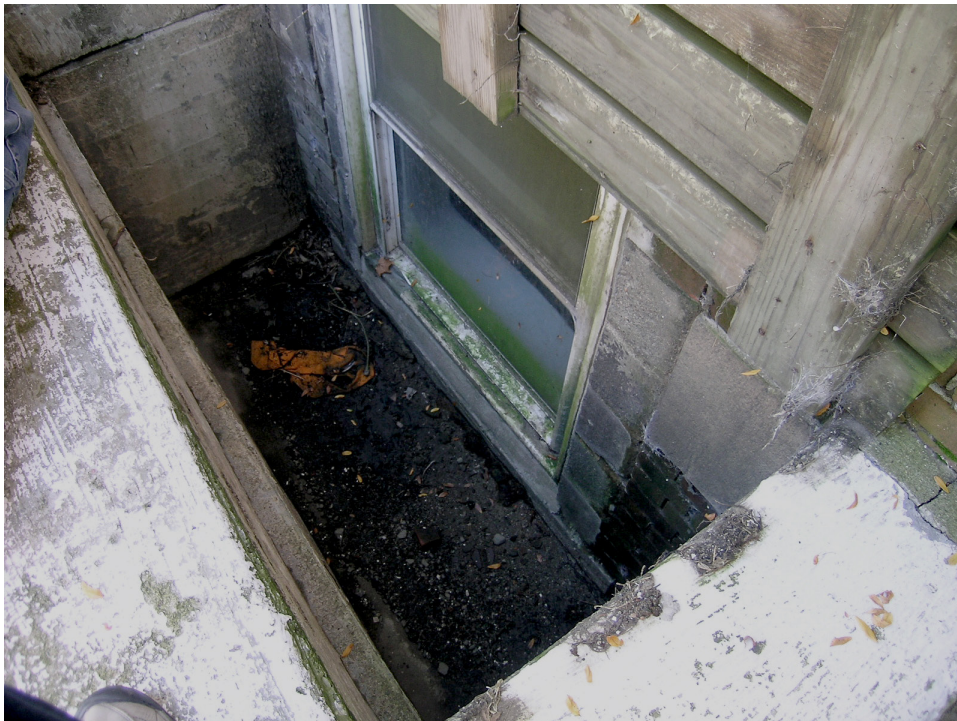
(Below) The original masonry opening of the northwest window well has been reduced with concrete block, and the contemporary replacement window is covered in biological growth. All window wells are damp. At the right, a large mortar patch was used to fill the gap where the top of the window well has frost jacked away from the wall. [JGWA 2014]

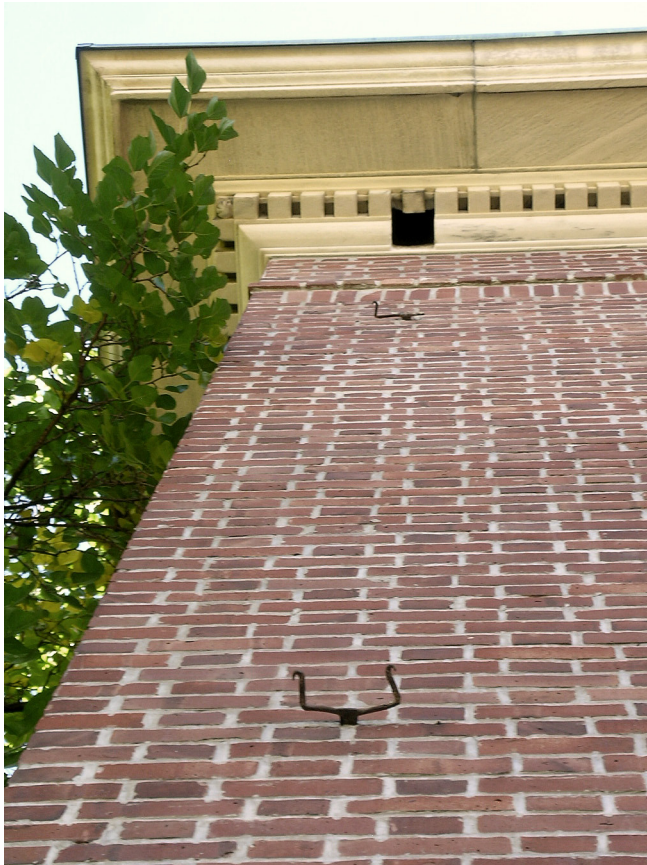
(Left) Former roof leader location and hangers. West elevation shown. Also note the proximity of mature trees on the north elevation. [JGWA 2014]

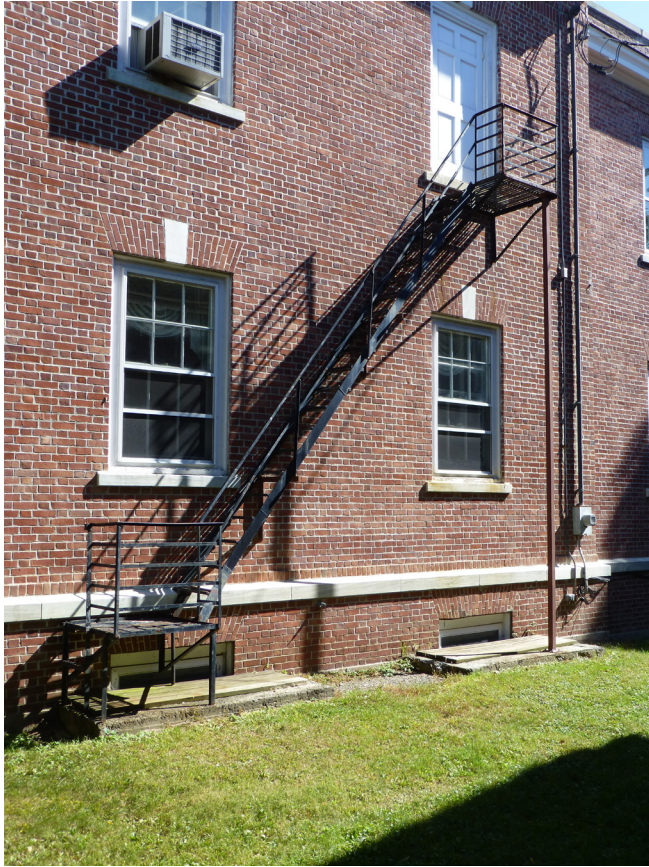
(Left) Electrical service entrance, metal fire escape, and second floor emergency exit in a historic window opening at the south elevation. [JGWA 2014]

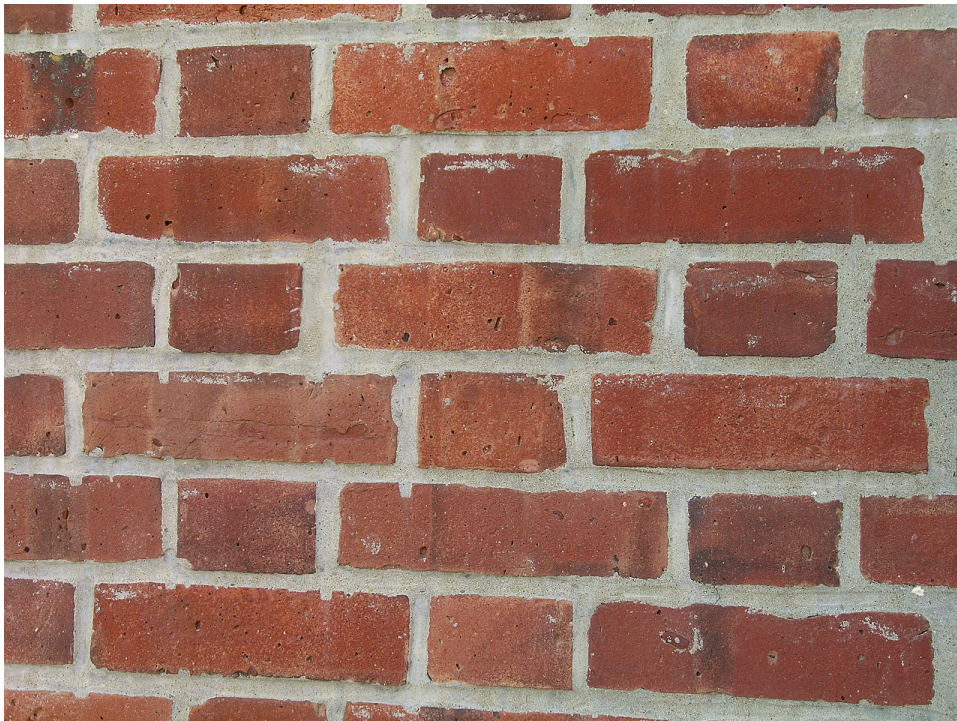
(Below) Use of mechanical saws in previous brick repointing campaigns has resulted in over-cut mortar joints. This is a typical condition. [JGWA 2014]

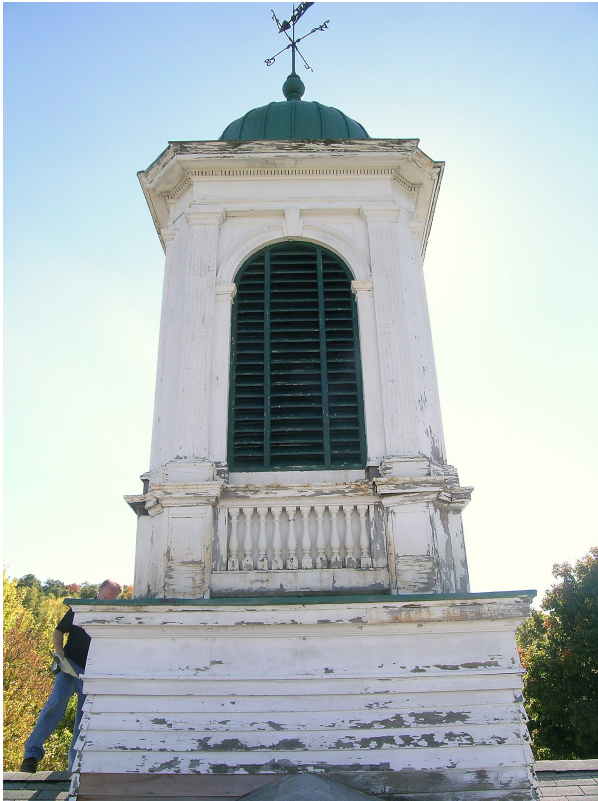
Cupola paint is badly worn and there are numerous areas of missing or inappropriate wood trim replacement. Metal roofing and flashing is poorly detailed. [JGWA 2014]

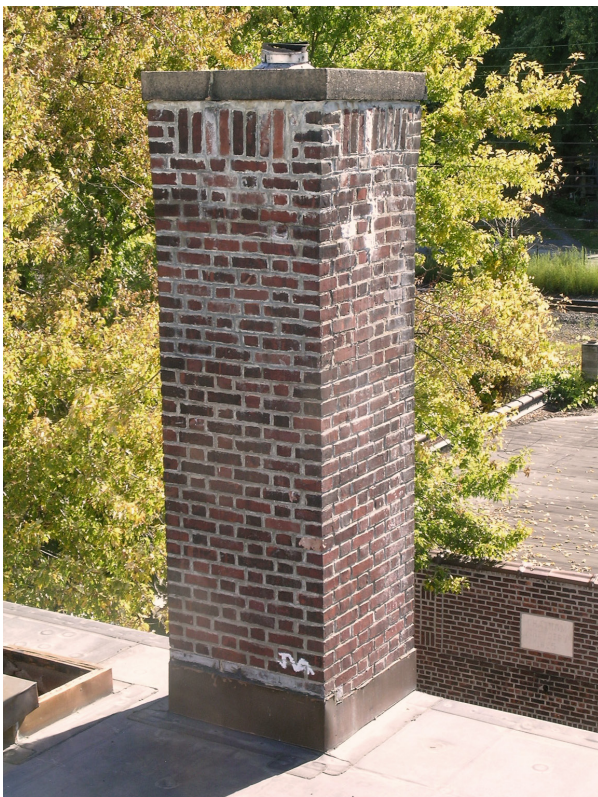
The chimney is no longer plumb, and leans slightly. Numerous joints have been repointed with inappropriate mortar or sealant. Cracked brick joints and units contribute to water infiltration and damage to the spaces below. [JGWA 2014]

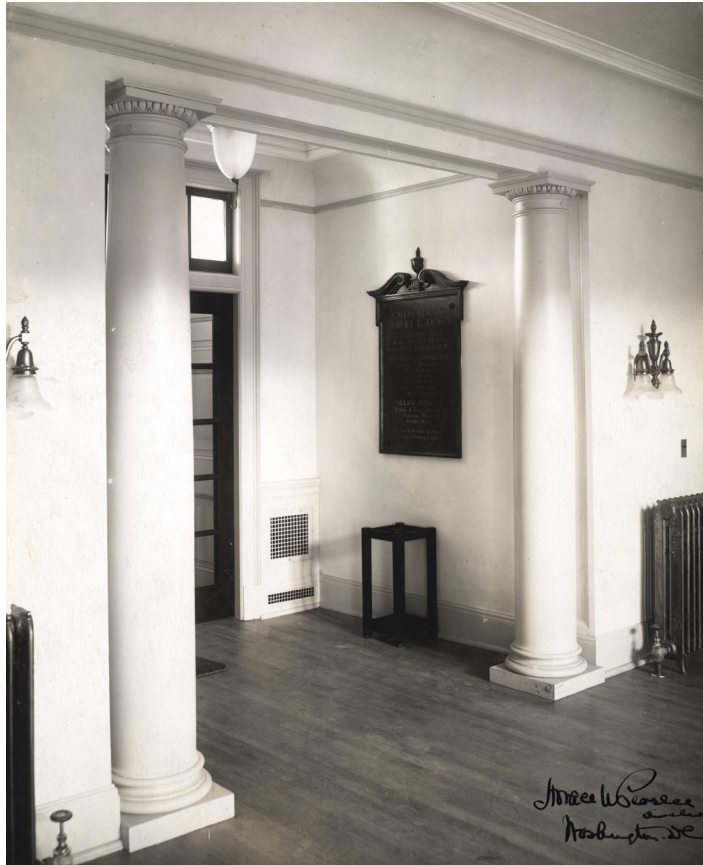
(Left) Historic photograph of Tracy Memorial Village Hall (Chatham, N.Y.). [Cornell University Library, ca.1913-ca.1950.]

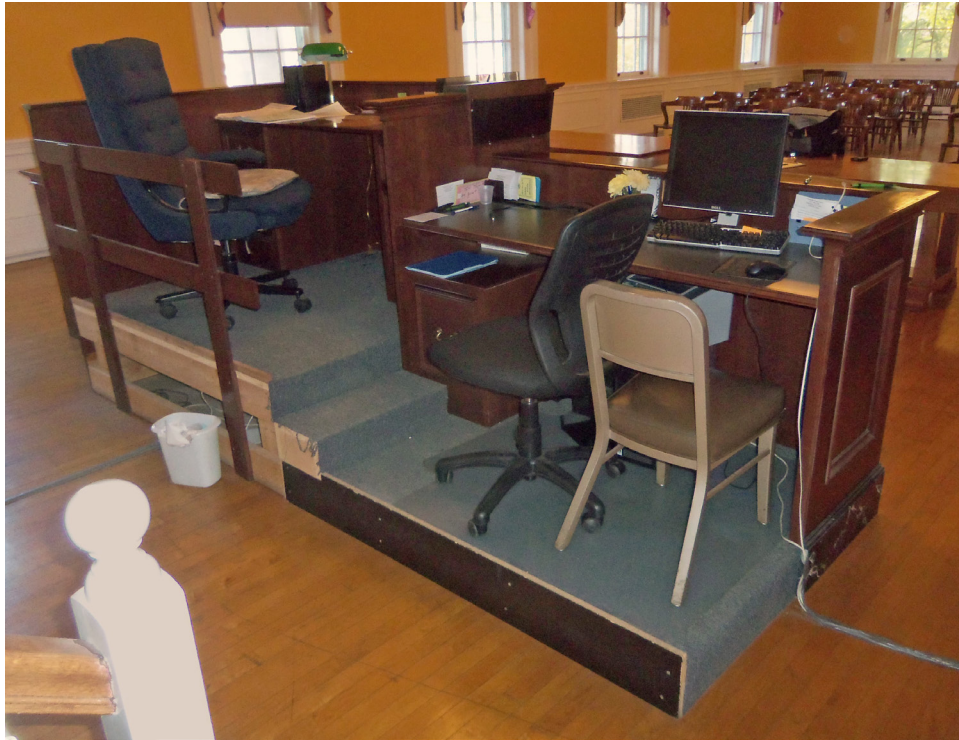
(Above) The judge's podium does not meet Americans with Disabilities Act requirements for accessibility. Communications wiring is taped to the floor on the right and electrical power is provided to the left with surface mounted wall conduit. Both are tripping hazards. [JGWA 2014]

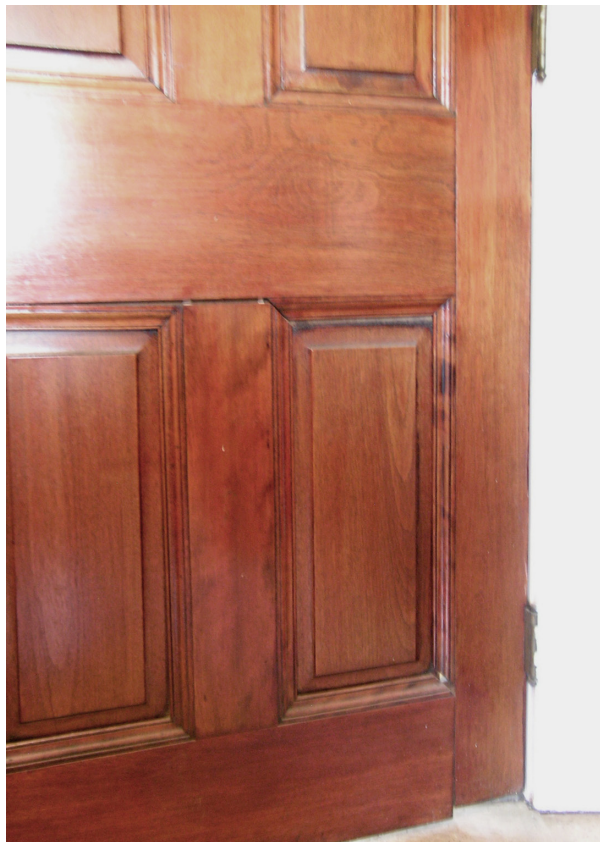
(Left) Many of the historic doors remain and are in good condition. However, some doors showed signs of deterioration, including failing hardware, sagging, and mis-aligned joints as shown here. [JGWA 2014]

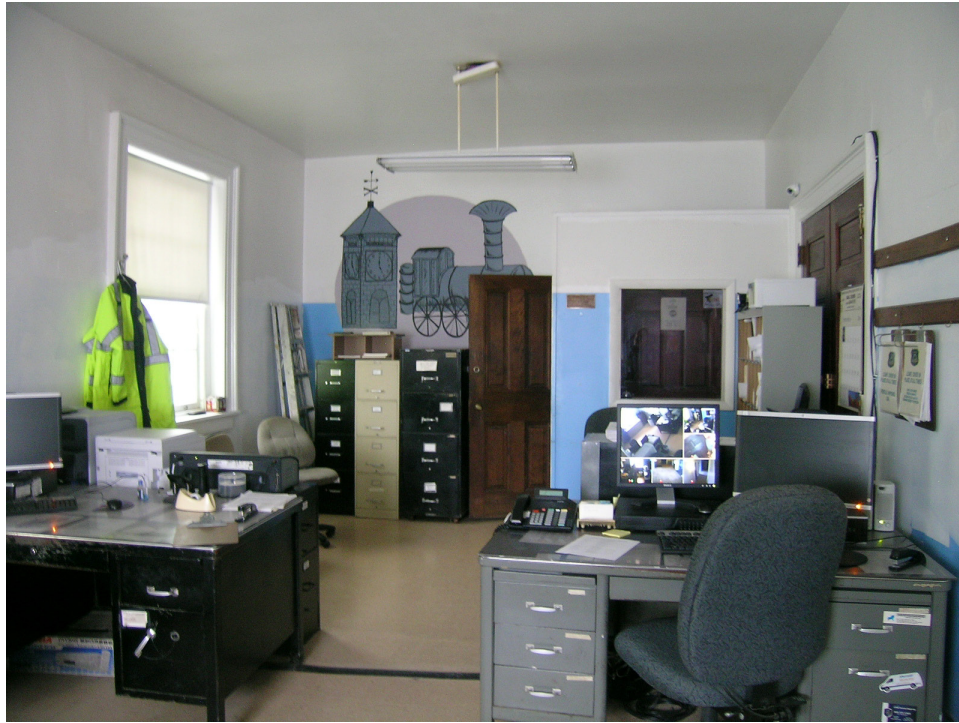
(Above) The village police offices have been greatly altered from their original conditions. Historic light fixtures have been replaced with fluorescent pendants, a vestibule has been added within this room, hardware has been removed from windows, and the floor has been covered in vinyl floor tile. [JGWA 2014]

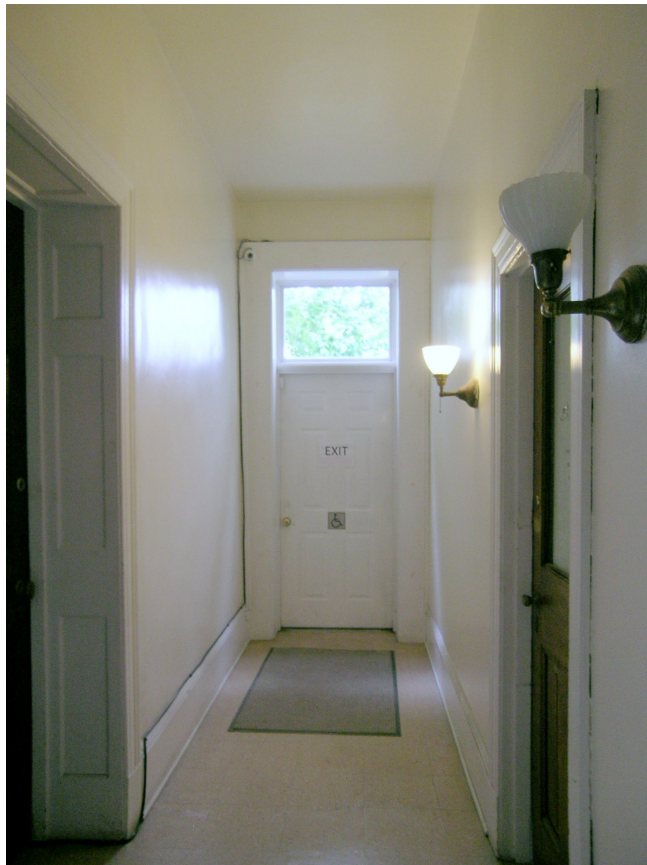
(Left) A hallway and door have been added at the northeast corner of the first floor to provide a wheelchair accessible entrance at the exterior ramp. The door and frame details are not consistent with the historic character of the building. [JGWA 2014]

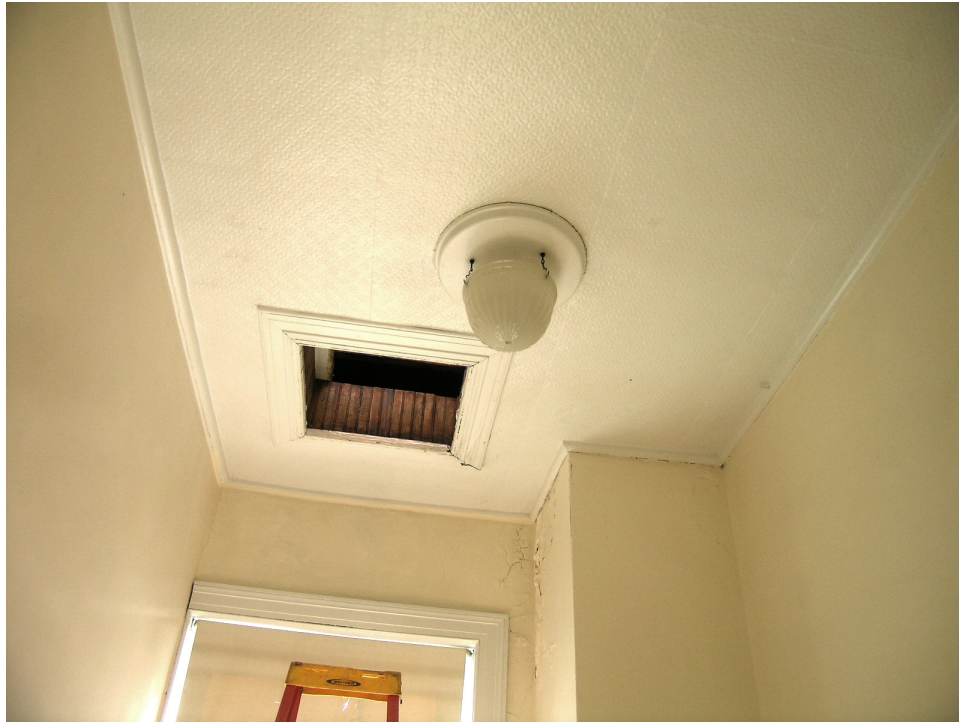
(Above) Second floor former bathroom. Historic metal ceiling appears to be in good condition, but wood trim around the roof hatch and the plaster wall finishes adjacent to the chimney show evidence of water damage. [JGWA 2014]

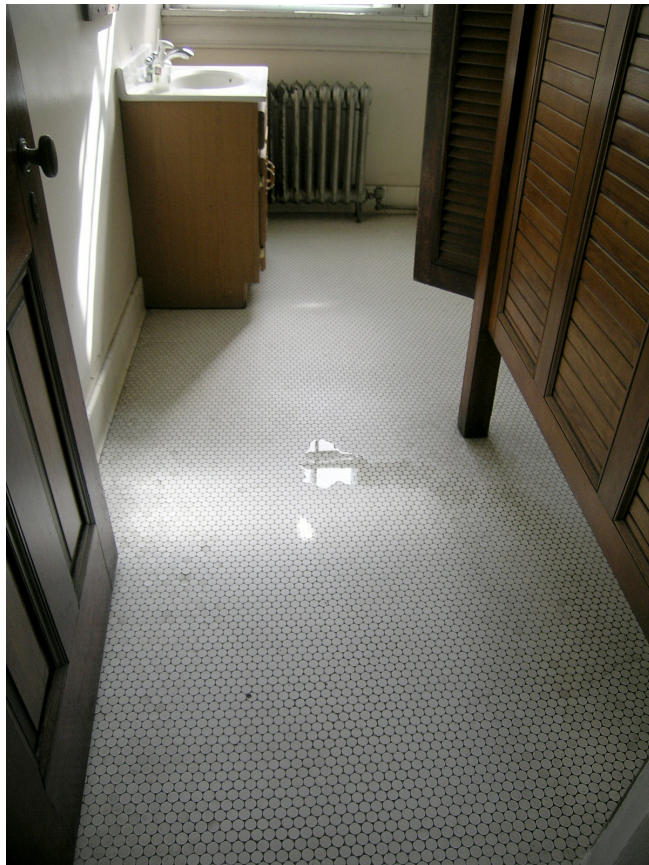
(Left) First floor women's toilet room. The wood toilet partition and penny floor tile appear to be historic. The sink and toilet have been replaced with modern residential grade fixtures, and the toilet appears to leak. [JGWA 2014]

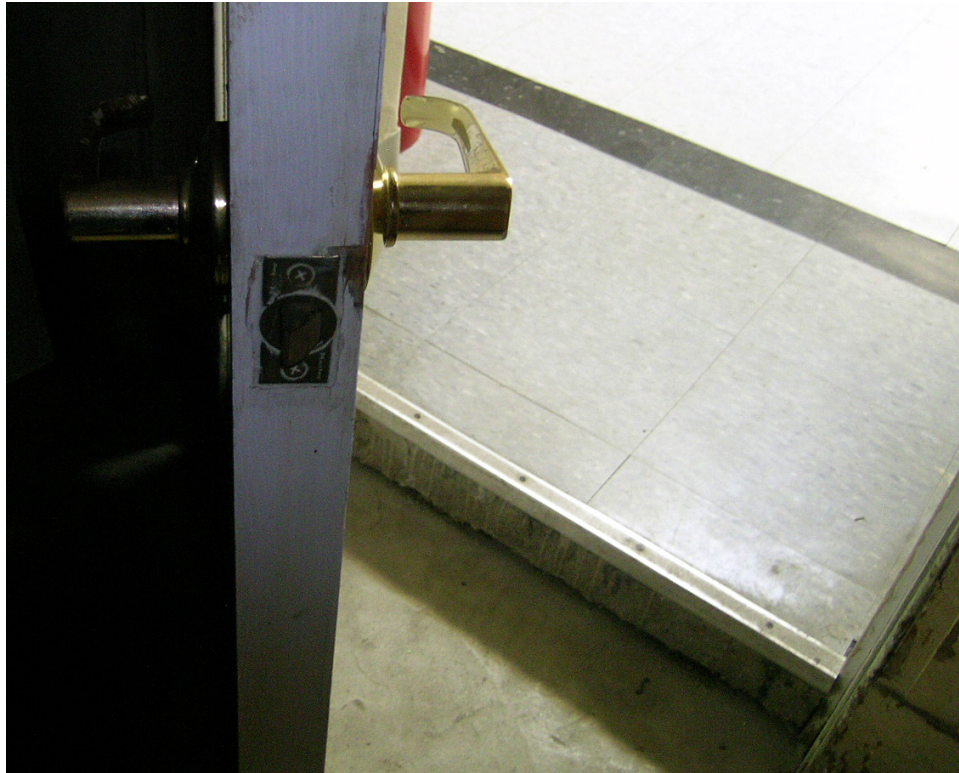
(Above) Typical Basement door. Most of the doors and hardware have been replaced, and are residential grade. Most of the doors have a 4" sloping step, as visible here, which is a tripping hazard. [JGWA 2014]

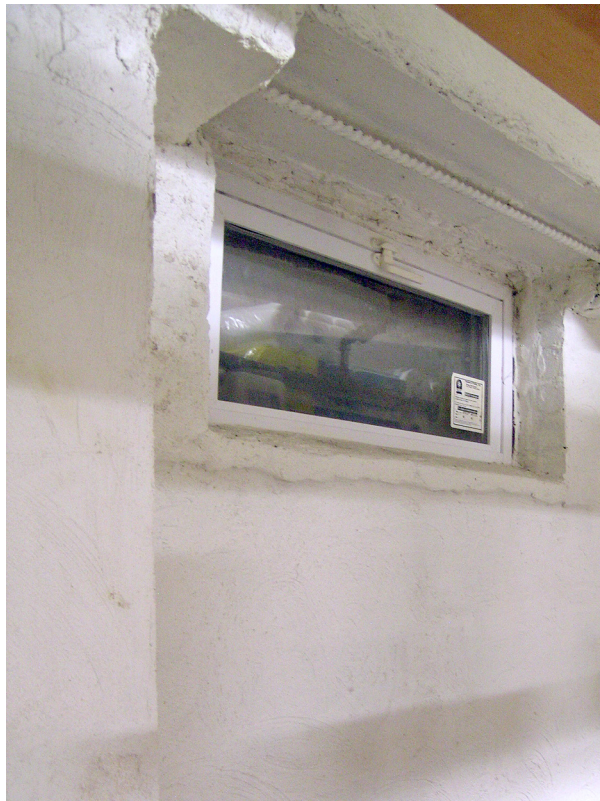
(Left) The west basement window on the north elevation, behind the wheelchair accessible ramp, has been modified. A portion of the concrete lintel above this opening has been removed, exposing the reinforcing, to accommodate a contemporary replacement window. [JGWA 2014]

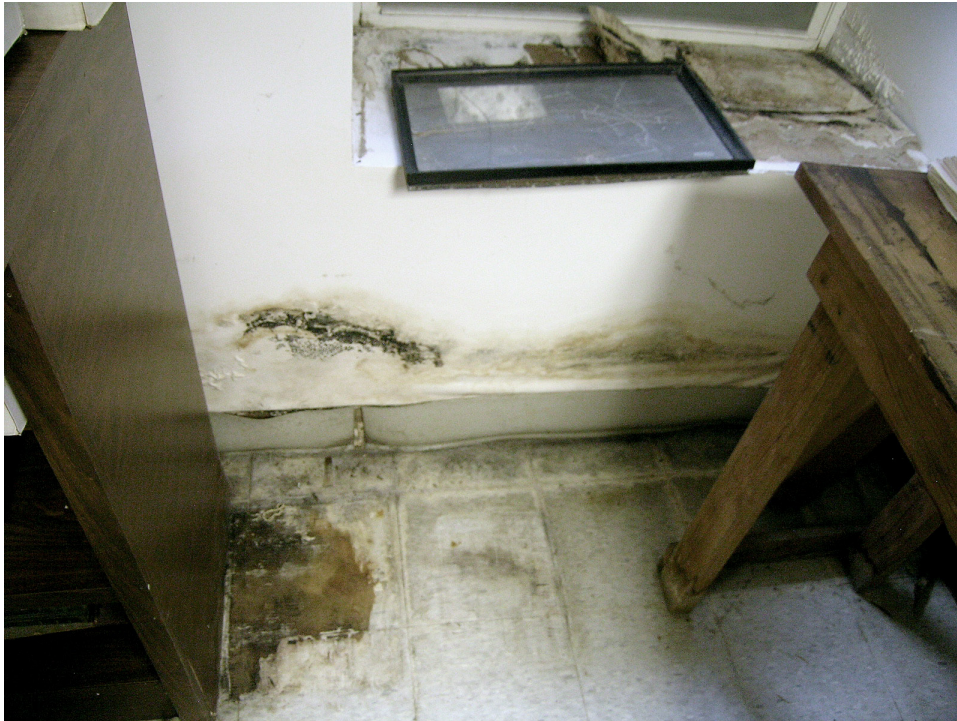
(Above) Rising damp in the basement walls has caused staining, dark mold growth, paint and adhesive failures in the floor and wall finishes. [JGWA 2014]

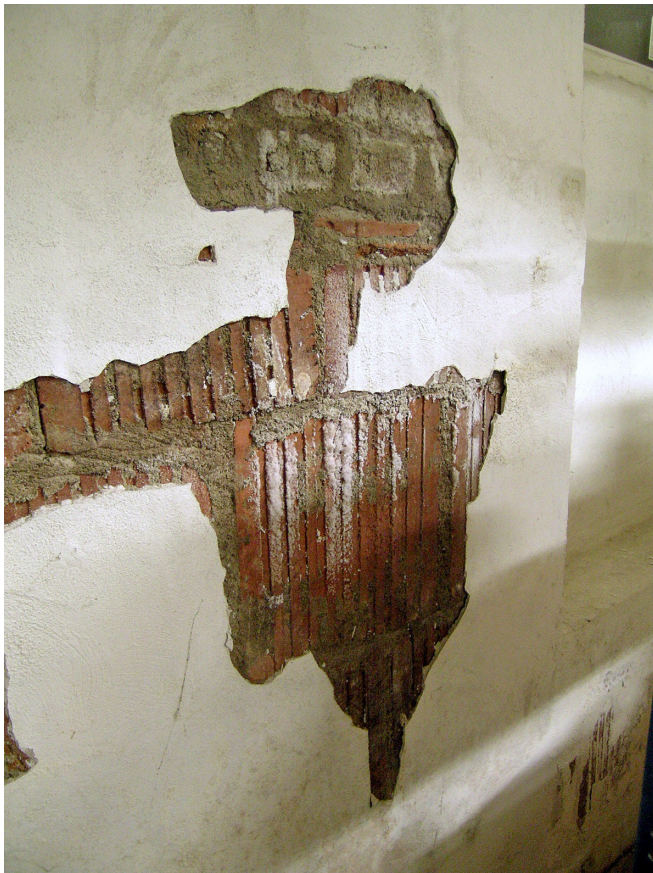
(Left) Rising damp has caused plaster wall finishes to spall from exterior basement walls. The white, substance on the terra cotta block appears to be mold. [JGWA 2014]

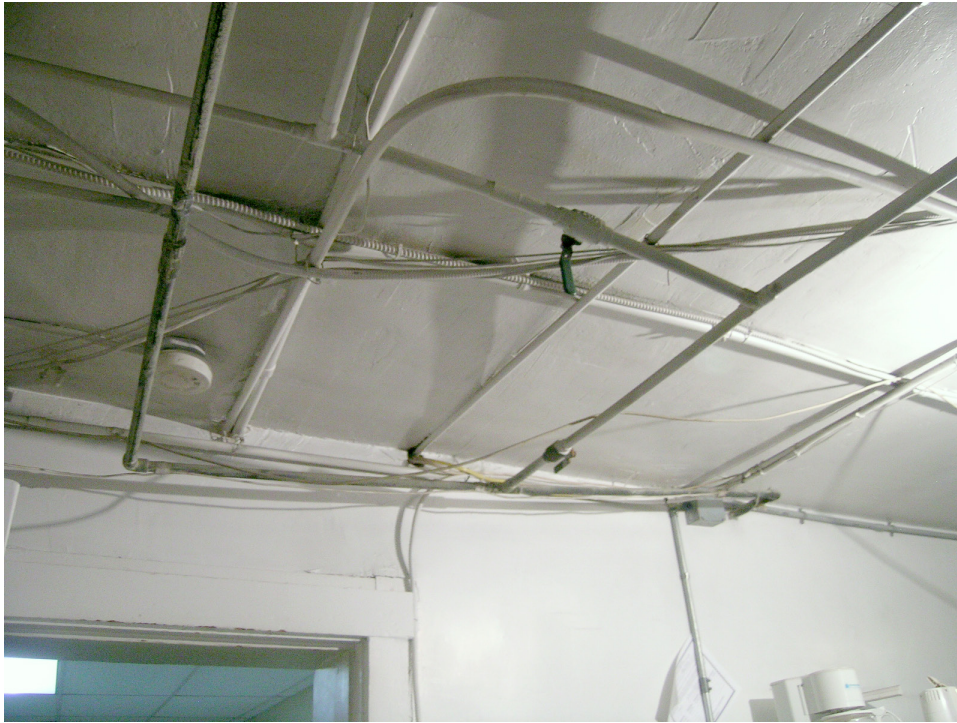
(Above) Many electrical and plumbing conduits are not properly anchored to the ceiling. In some locations they are merely propped up by other pipes. [JGWA 2014]

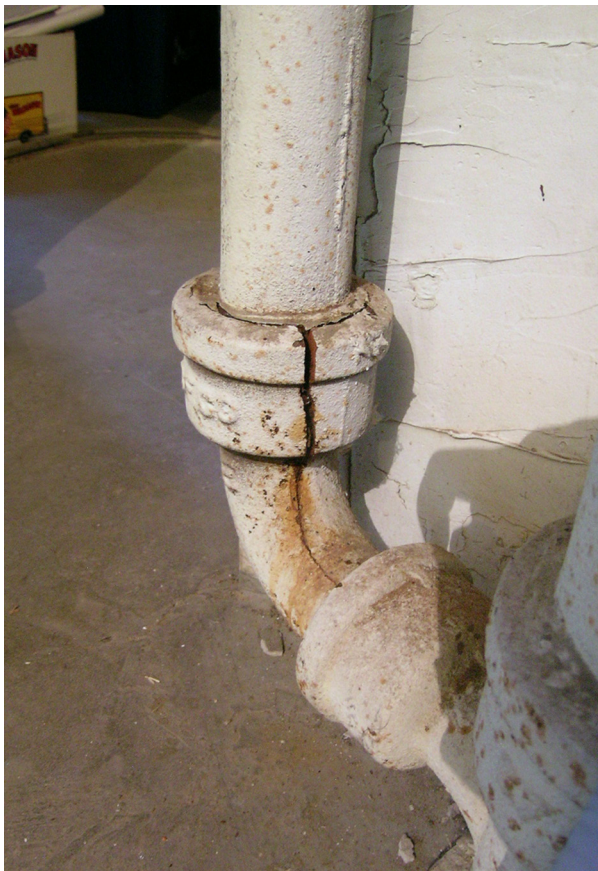
(Left) Several cracked cast-iron waste pipe fittings were noted in the basement. [JGWA 2014]

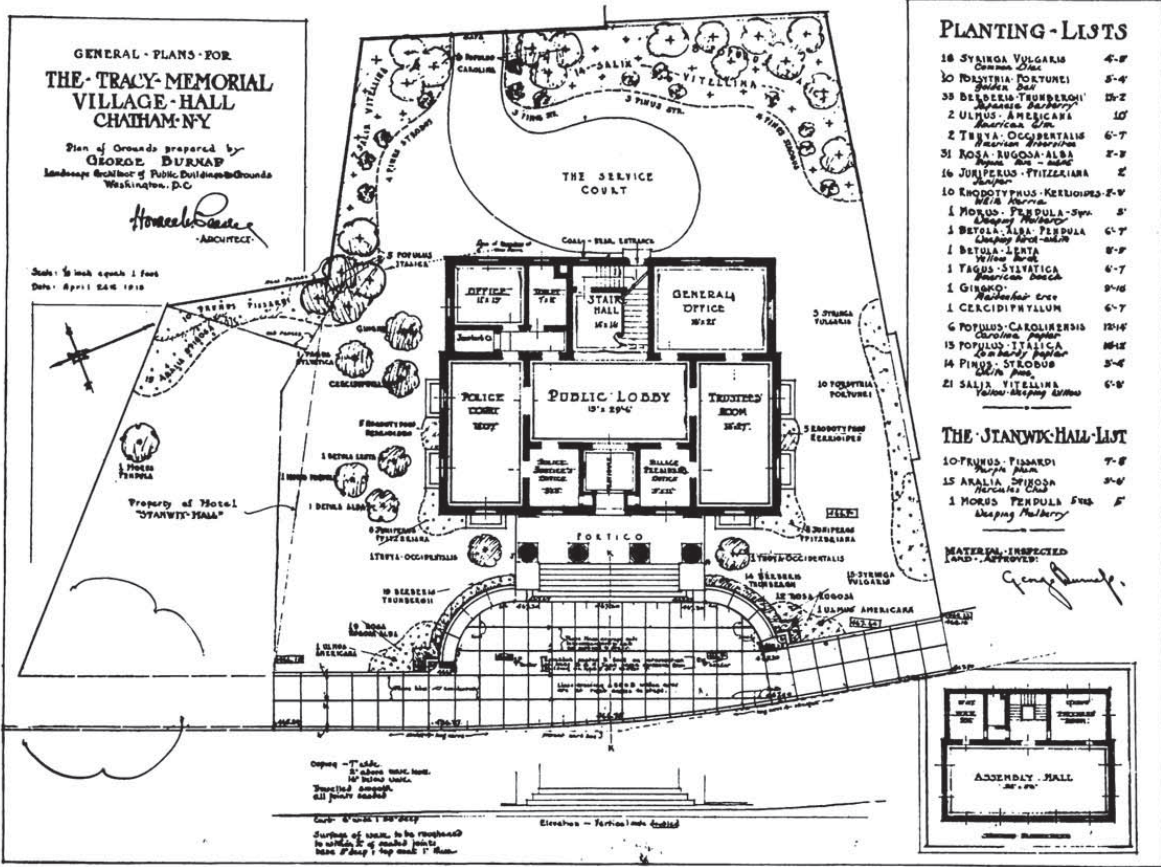
TRACY MEMORIAL VILLAGE HALL, CHATHAM, N. Y.
 MR. HORACE W. PEASLEE, ARCHITECT
